# TEST REPORT

Report No. : 23-009164-02-2

Description : Smart Position Transmitter

Model Name : TS500

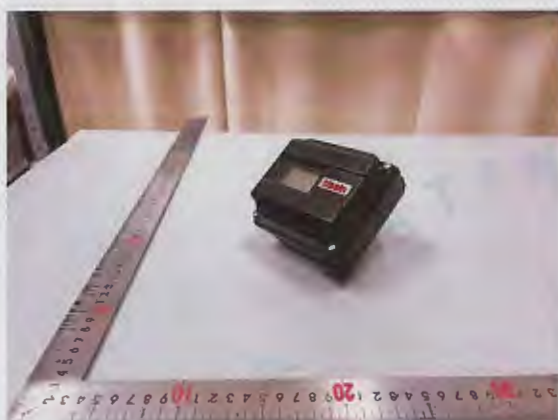
[Fig. 1: Sample]

- Description : Smart Position Transmitter
- Model Name : TS500
- Dimensions : 102.8 mm × 113.6 mm × 98.6 mm

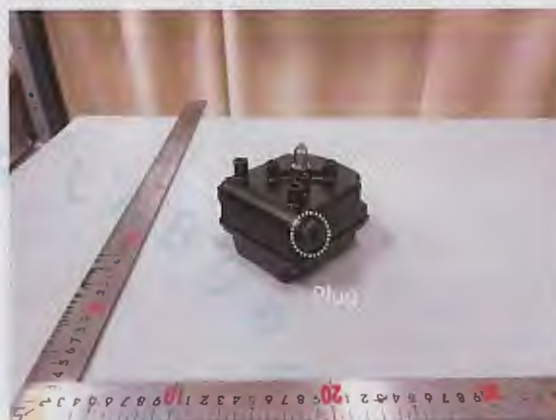
[Fig. 2: Sample]

The test was conducted with the plug applied on the entry of the sample (Refer to Fig. 2)

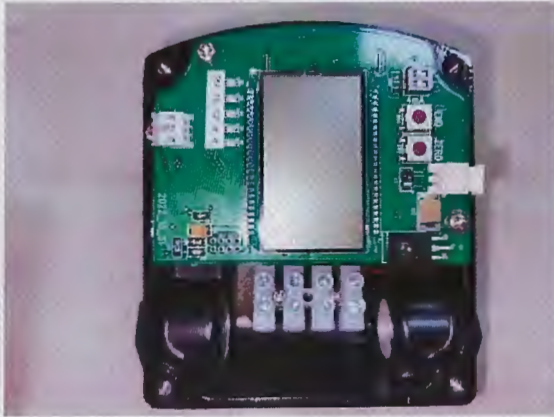
[Fig. 5: IP6X]

| Code Letters | IP | Conditions & Results |
|---|---|---|
| 1st<br>Characteristic<br>numerals<br>Against ingress<br>of solid foreign<br>objects | 6 | <b>2.1 Dust Test Conditions</b> <ul style="list-style-type: none"> <li>Talcum powder(mesh) wire diameter: 50 <math>\mu\text{m}</math></li> <li>Talcum powder(mesh) wire width: 75 <math>\mu\text{m}</math></li> <li>Amount of talcum powder of the test chamber: 2 <math>\text{kg/m}^3</math></li> </ul> <b>2.2 Dust Test Contents</b> <ul style="list-style-type: none"> <li>Volume of the enclosures: About 438 <math>\text{cm}^3</math></li> <li>Reduction air pressure: - 2.00 kPa</li> <li>Flow Rate: About 0.01 L/min</li> <li>Extraction rate per hour: About 1.37 volumes/h</li> <li>Test duration: 8 h</li> </ul> |
| | | <b>2.3 Dust Test Result</b> <ul style="list-style-type: none"> <li>Pass</li> </ul> |

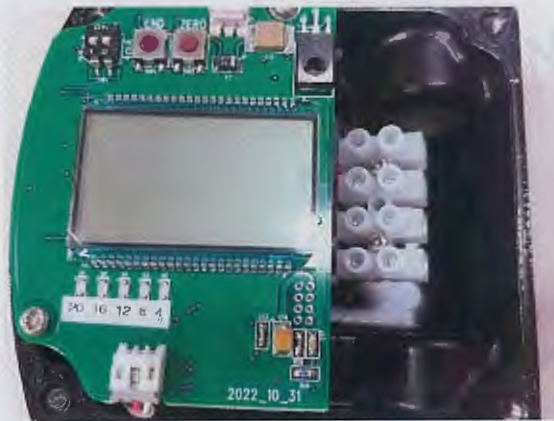
[Fig. 6: IPX7]

| Code Letters | IP | Conditions & Results |
|---|---|---|
| 2nd<br>Characteristic<br>numerals<br>Against ingress<br>of water with<br>harmful effects | 7 | <b>2.4 Water Test Conditions</b> <ul style="list-style-type: none"> <li>The lowest point of enclosure: 1 000 mm</li> <li>The highest point of enclosure: 885 mm</li> <li>Differential temperature of water and enclosure (less than 5.0 K): Under 2.0 K</li> </ul> <b>2.5 Water Test Contents</b> <ul style="list-style-type: none"> <li>Test duration: 30 min</li> </ul> |
| | | <b>2.6 Water Test Result</b> <ul style="list-style-type: none"> <li>Pass</li> </ul> |
