# TEST REPORT

Report No. : 23-026980-01-2

Description : Smart Valve Positioner

Model Name : TS700

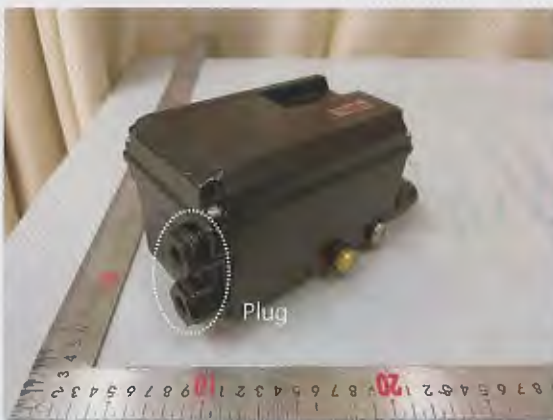
[Fig. 1: Sample]

- Description : Smart Valve Positioner
- Model Name : TS700
- Dimensions : 209.5 mm × 106.0 mm × 112.1 mm

The cable entry was assembled with the plug (Refer to the Fig.1).

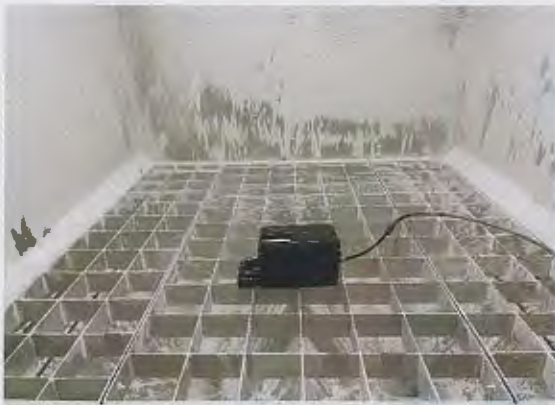
[Fig. 3: IP6X]

| Code Letters | IP | Conditions & Results |
|---|---|---|
| <b>1st</b><br><b>Characteristic numerals</b><br>Against ingress of solid foreign objects | 6 | <b>2.1 Dust Test Conditions (Category 1)</b> <ul style="list-style-type: none"> <li>Amount of talcum powder in the test chamber: 2 kg/m<sup>3</sup></li> <li>* Talcum powder: Pass through a square-meshed sieve (wire diameter: 50 μm, gap of wire: 75 μm)</li> <li>Internal free volume of the sample: 1 400 cm<sup>3</sup></li> <li>Depression of sample: - 2.00 kPa</li> <li>Extraction flow rate: About 0.10 L/min</li> <li>Extraction rate of volume per hour: About 4.29</li> <li>Test duration: 8 h</li> </ul> |

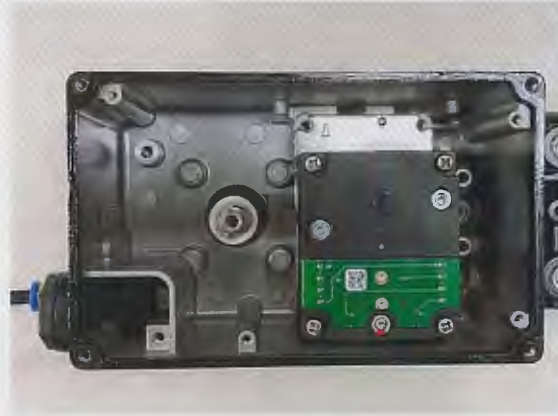
## 5. Dust Test Result Figures

| Code Letters | IP | Conditions & Results |
|---|---|---|
| | | <b>2.2 Dust Test Result</b> <ul style="list-style-type: none"> <li>Pass</li> </ul> |

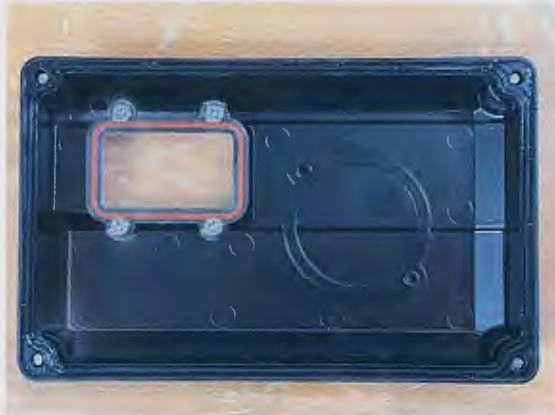
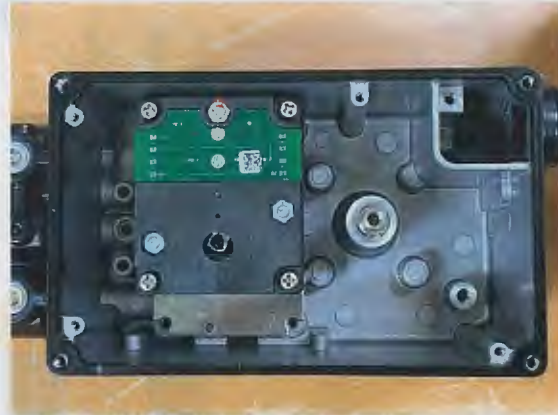
## 6. Water Test Result Figures

| Code Letters | IP | Conditions & Results |
|---|---|---|
| | | <b>2.4 Water Test Result</b> <ul style="list-style-type: none"> <li>Pass</li> </ul> |
